**Laconia 16144**  
**US Route 3 over New Hampshire Railroad (Br. No. 131/154)**  
**Public Informational Meeting**

**June 23, 2015**

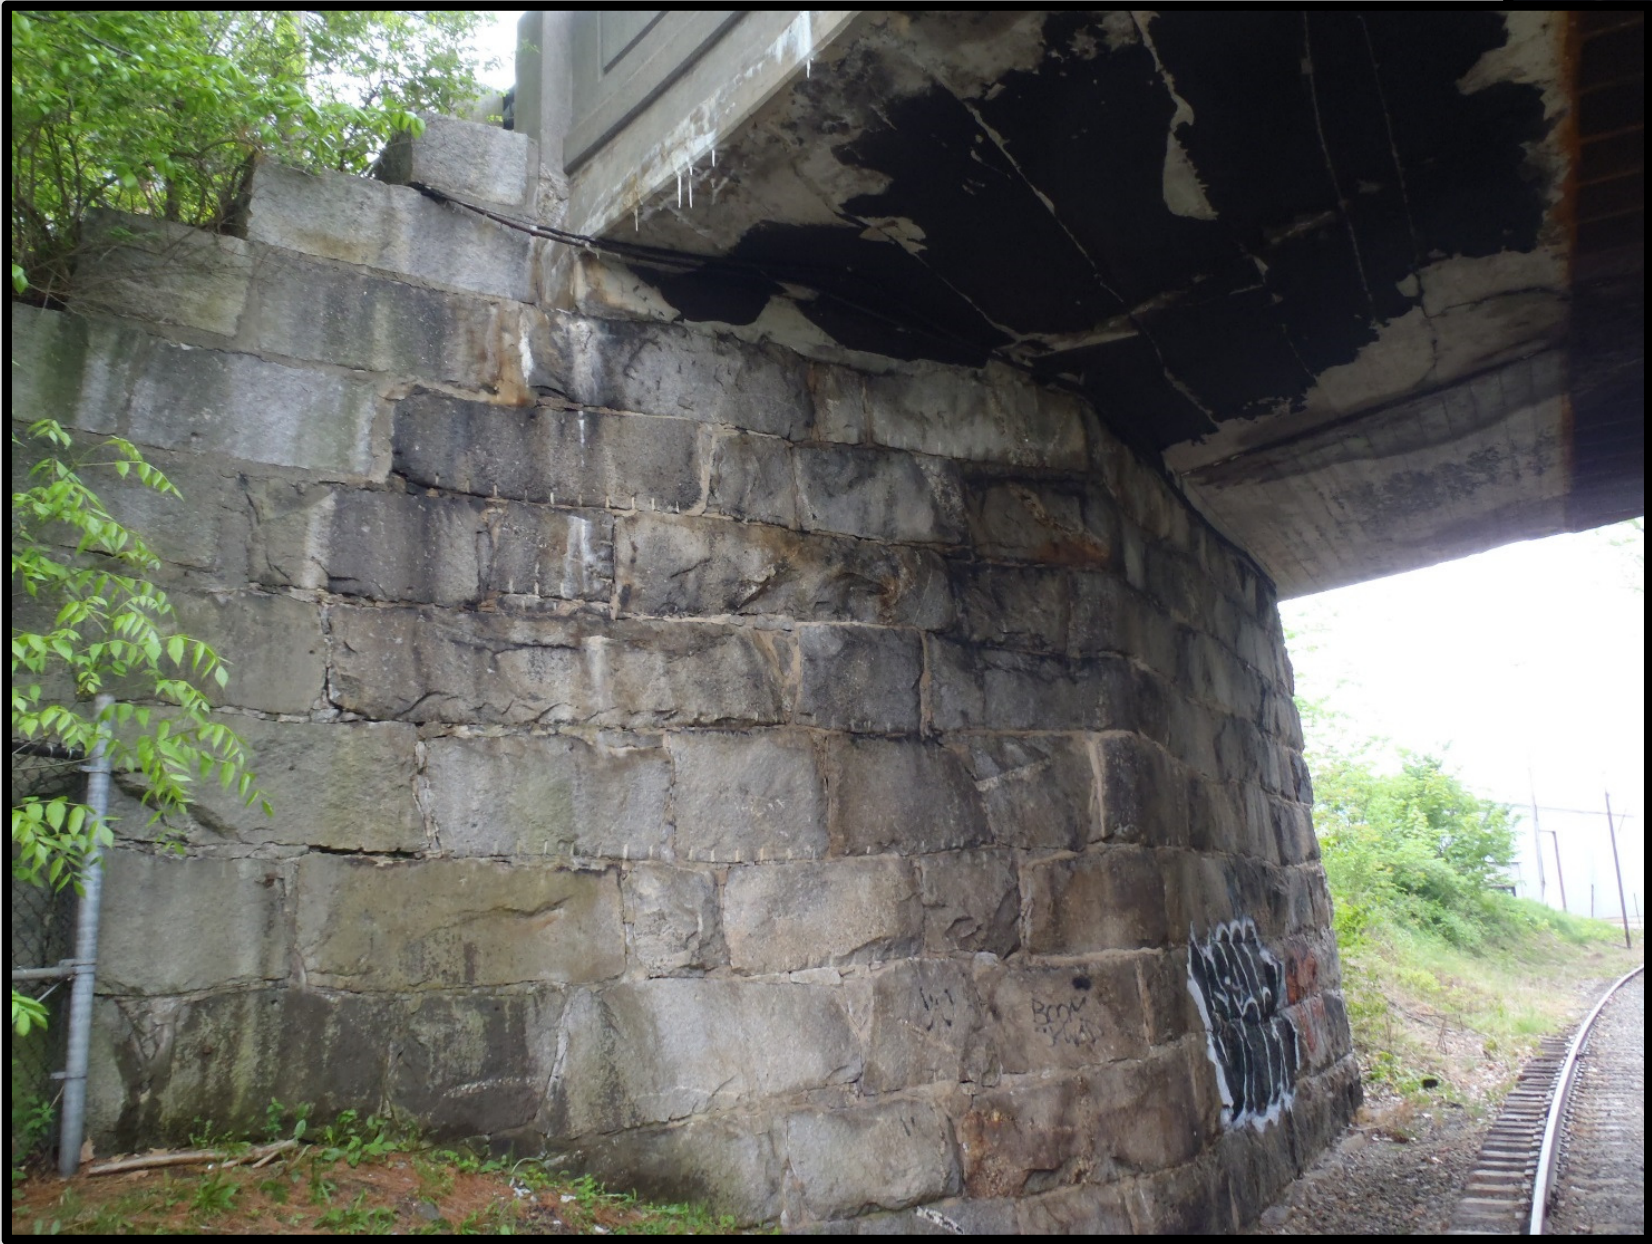
East Abutment

- Is primarily made up of split granite block abutments, built prior to 1933  
(there are no existing records of their construction)
- In 1933 the abutments were widened with mass concrete along with a wingwall along Lakeside Ave.

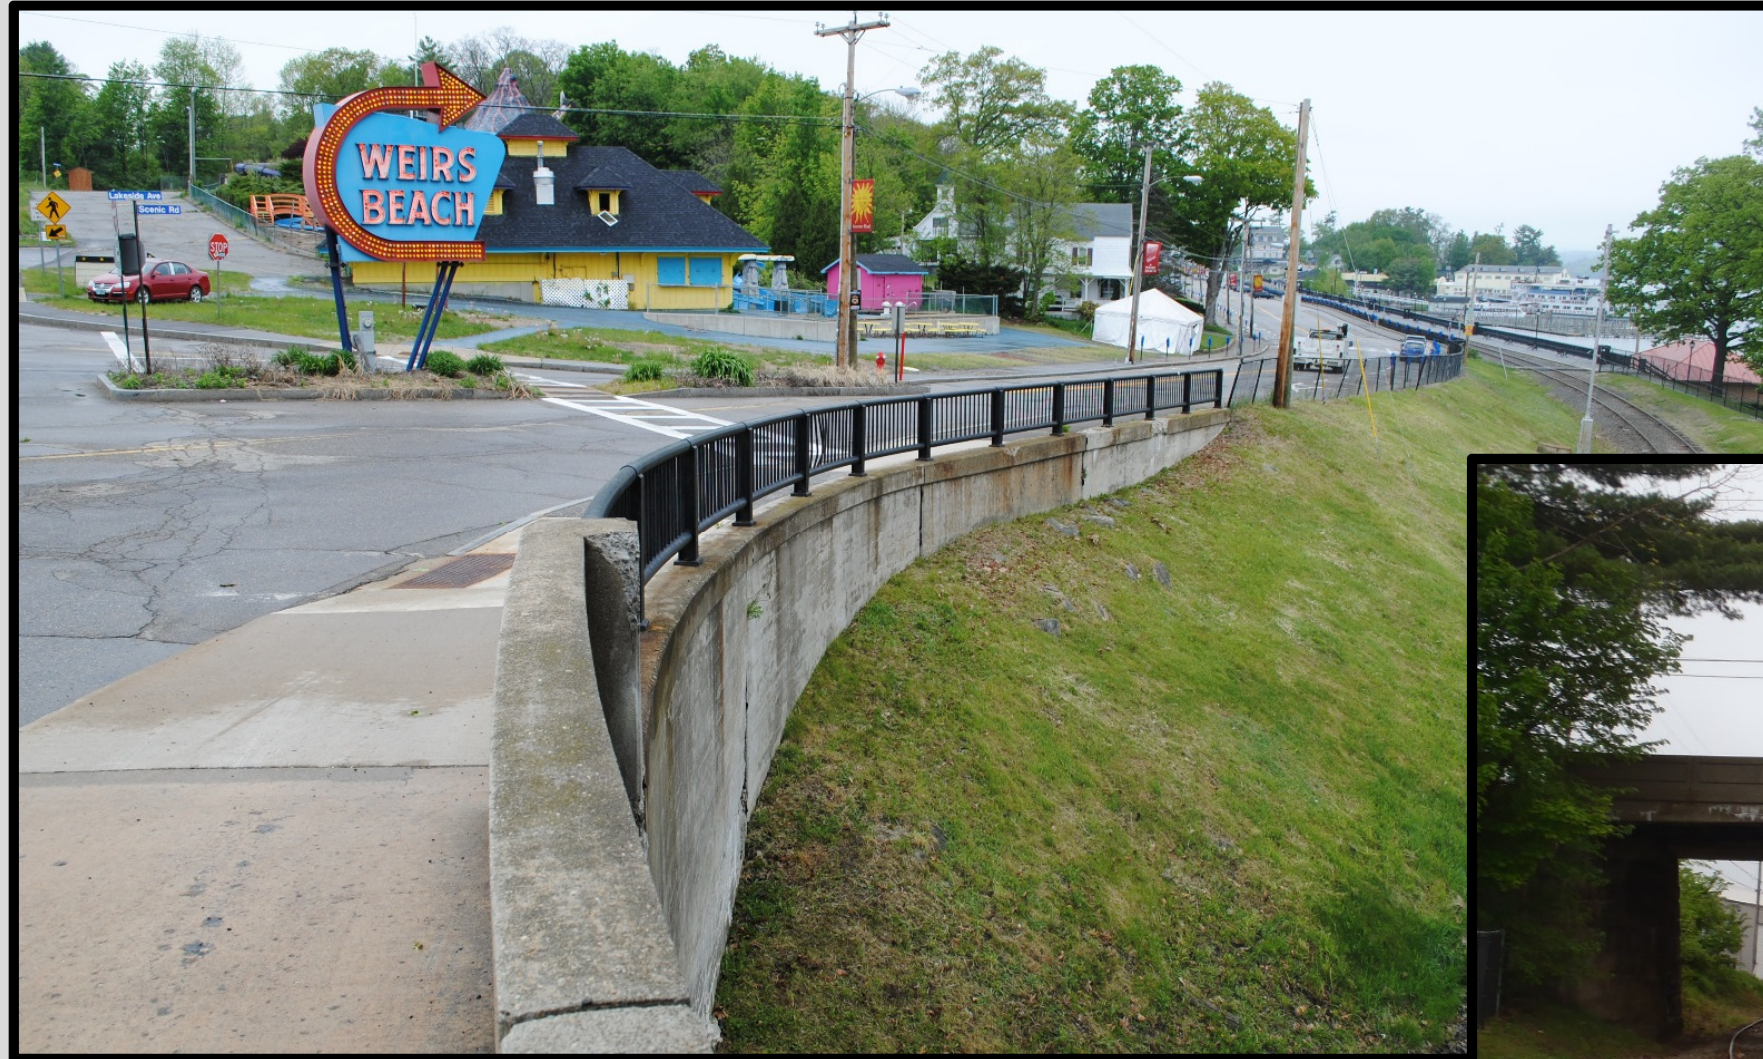
Retaining Wall – From Above

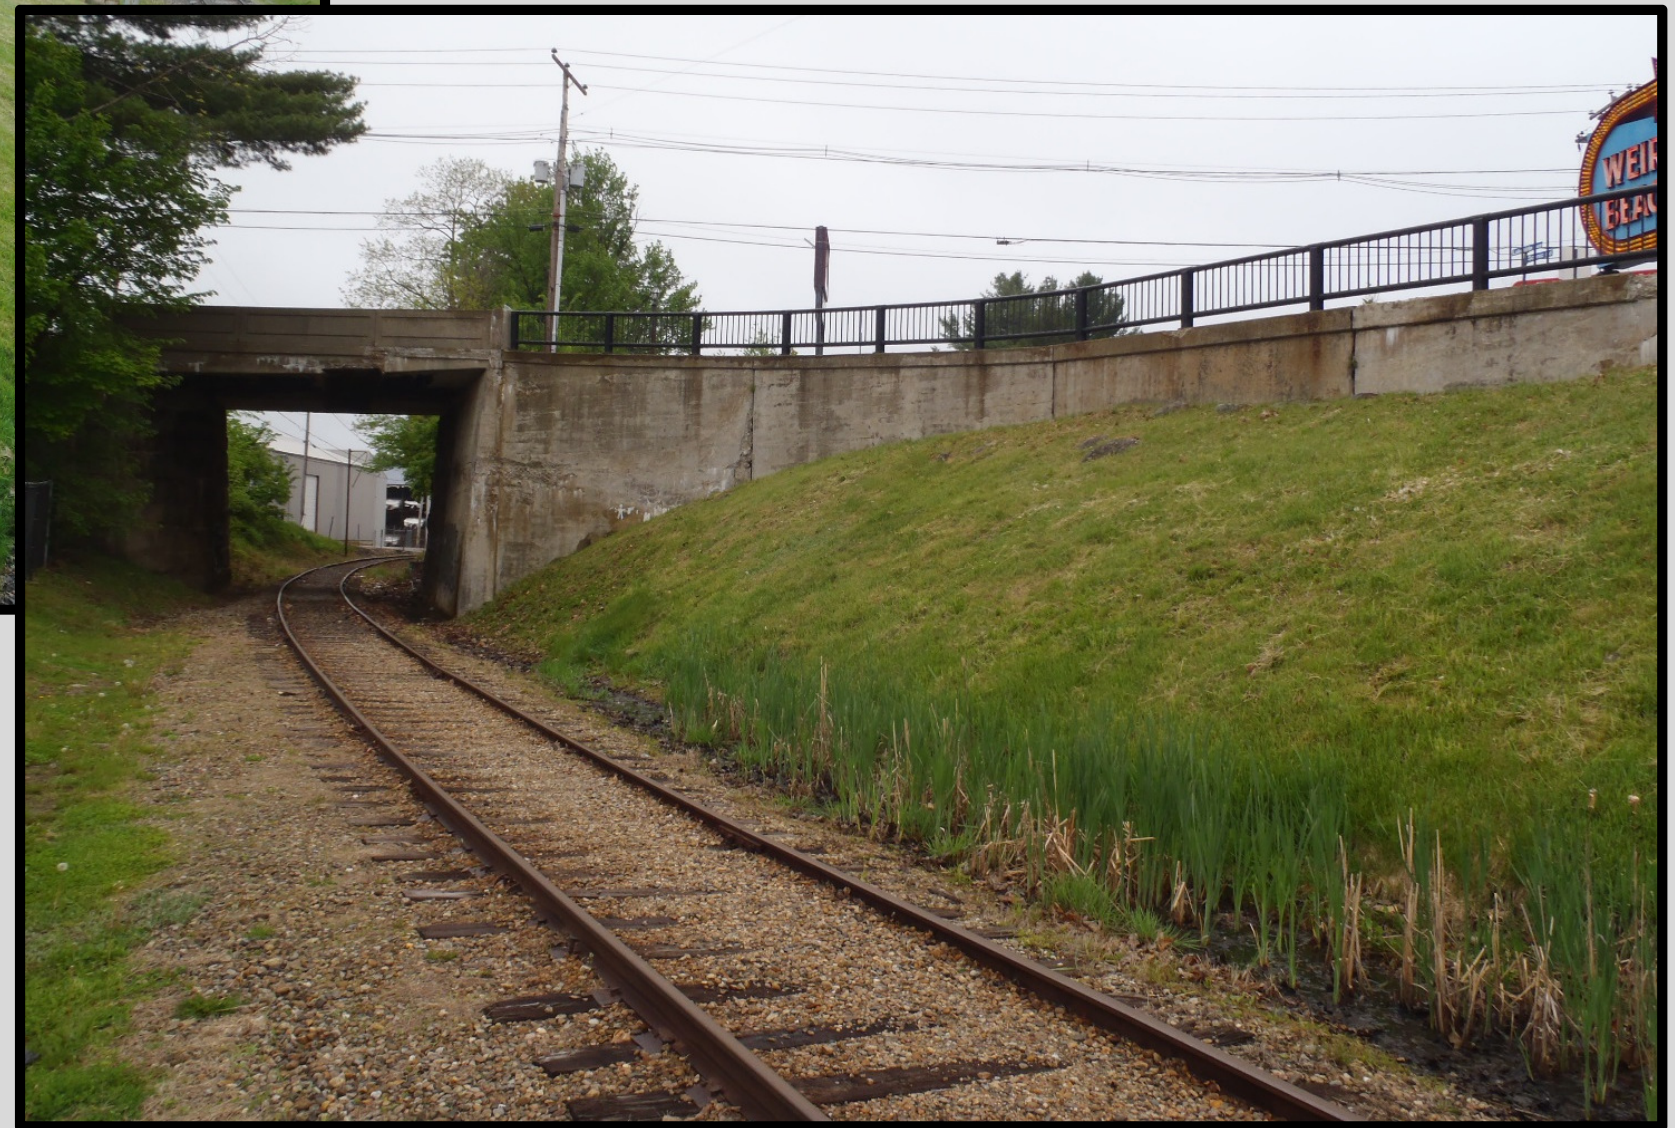
Retaining Wall – From Below

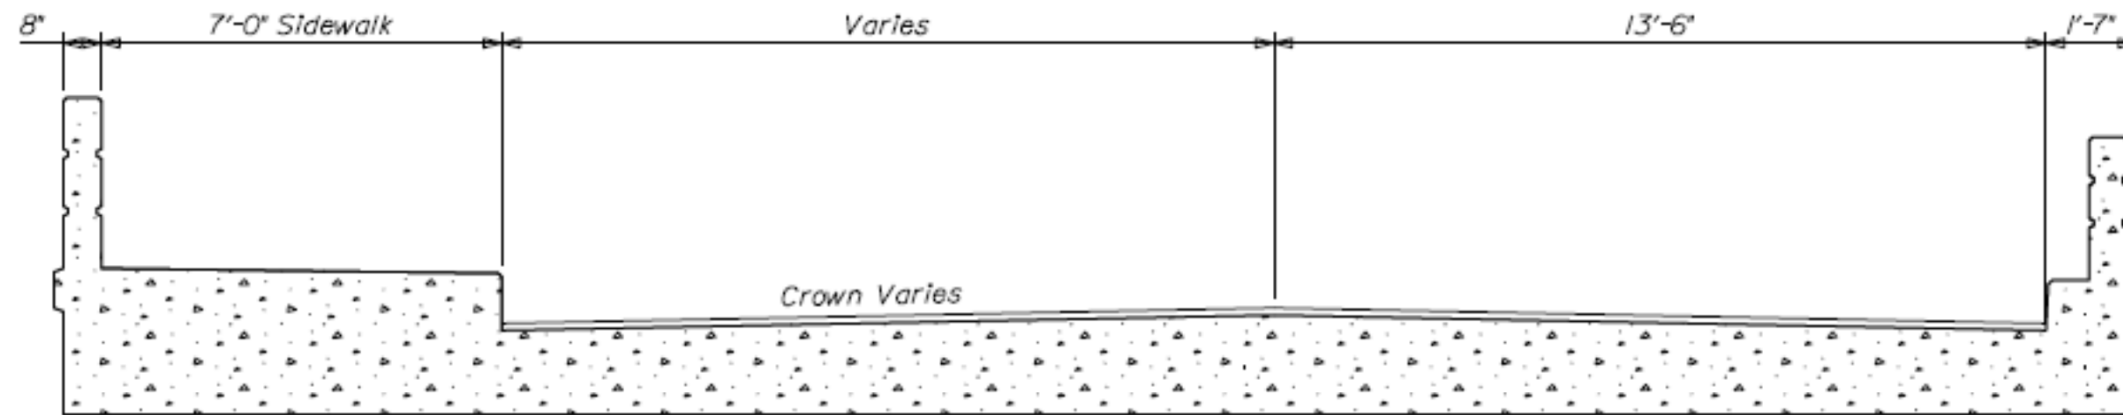
**Superstructure Section**

Existing Superstructure  
N.T.S.

Cast-In-Place Concrete Deck

- Is a Cast-In-Place (CIP) Concrete Slab constructed in 1933
- It's a 23' to 32 ' long single span which carries US Route 3 over NHRR
- The narrowest roadway width is 27 ' between curbs, 7' wide sidewalk along the north side of the bridge
- The railroad vertical clearance is 17.5 ' from top of rail to bottom of slab

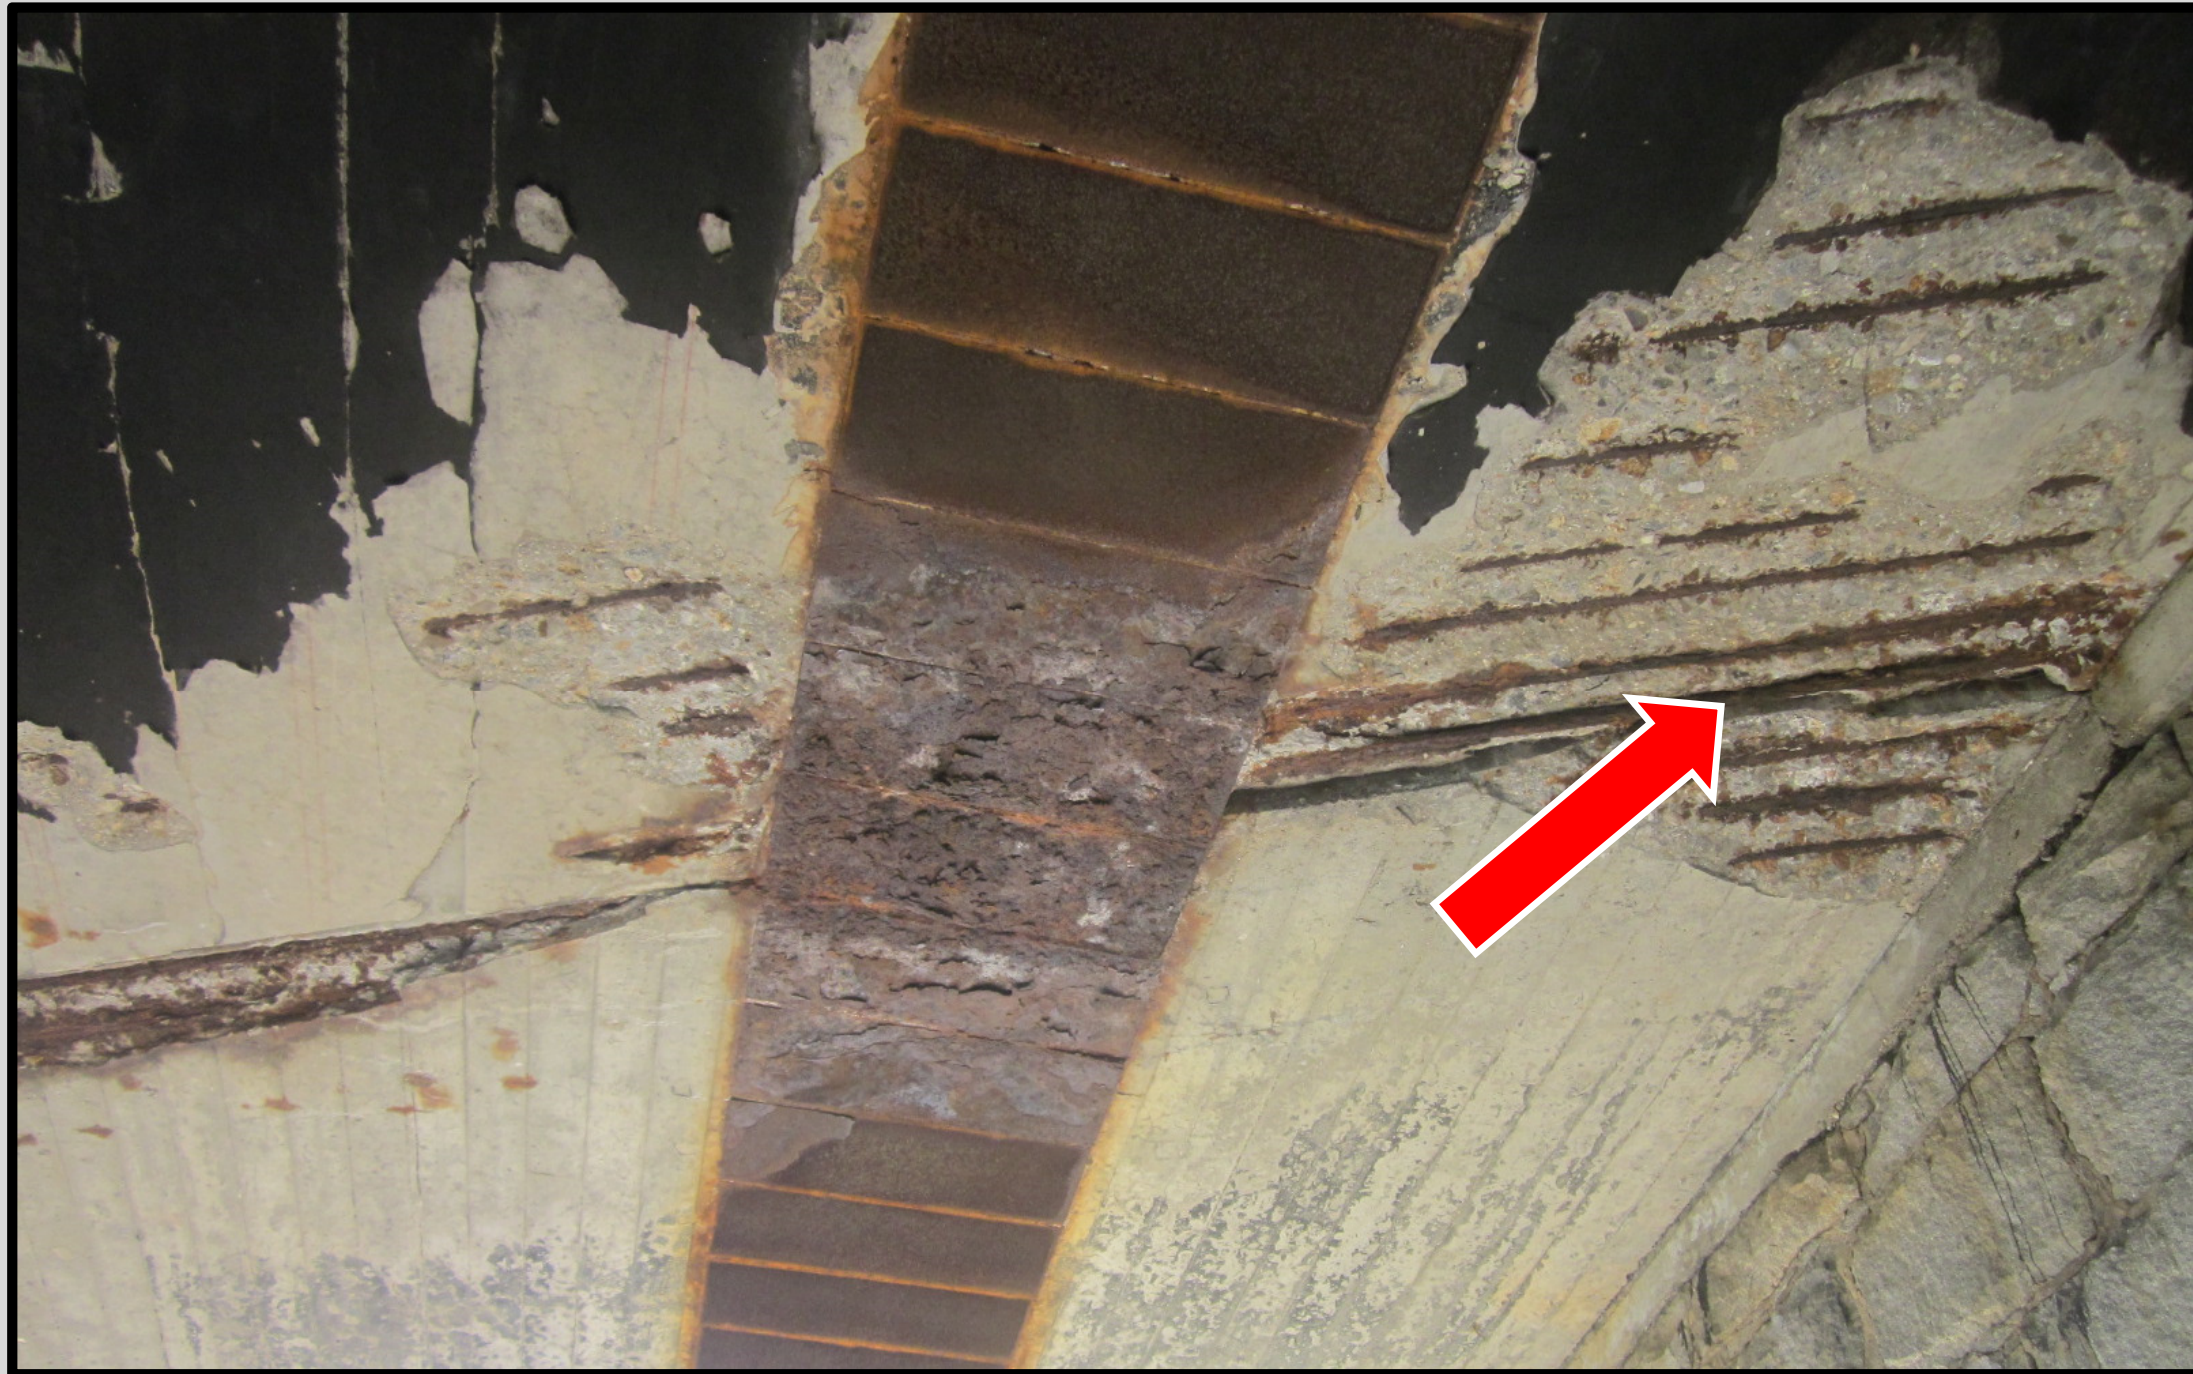
**Underside of Bridge Deck – Exposed Reinforcement**

- **Superstructure:** Poor condition, needs Replacement
- **Abutments:** Fair Condition, can be Rehabilitated
- **Wingwalls:** Fair Condition, can be Rehabilitated

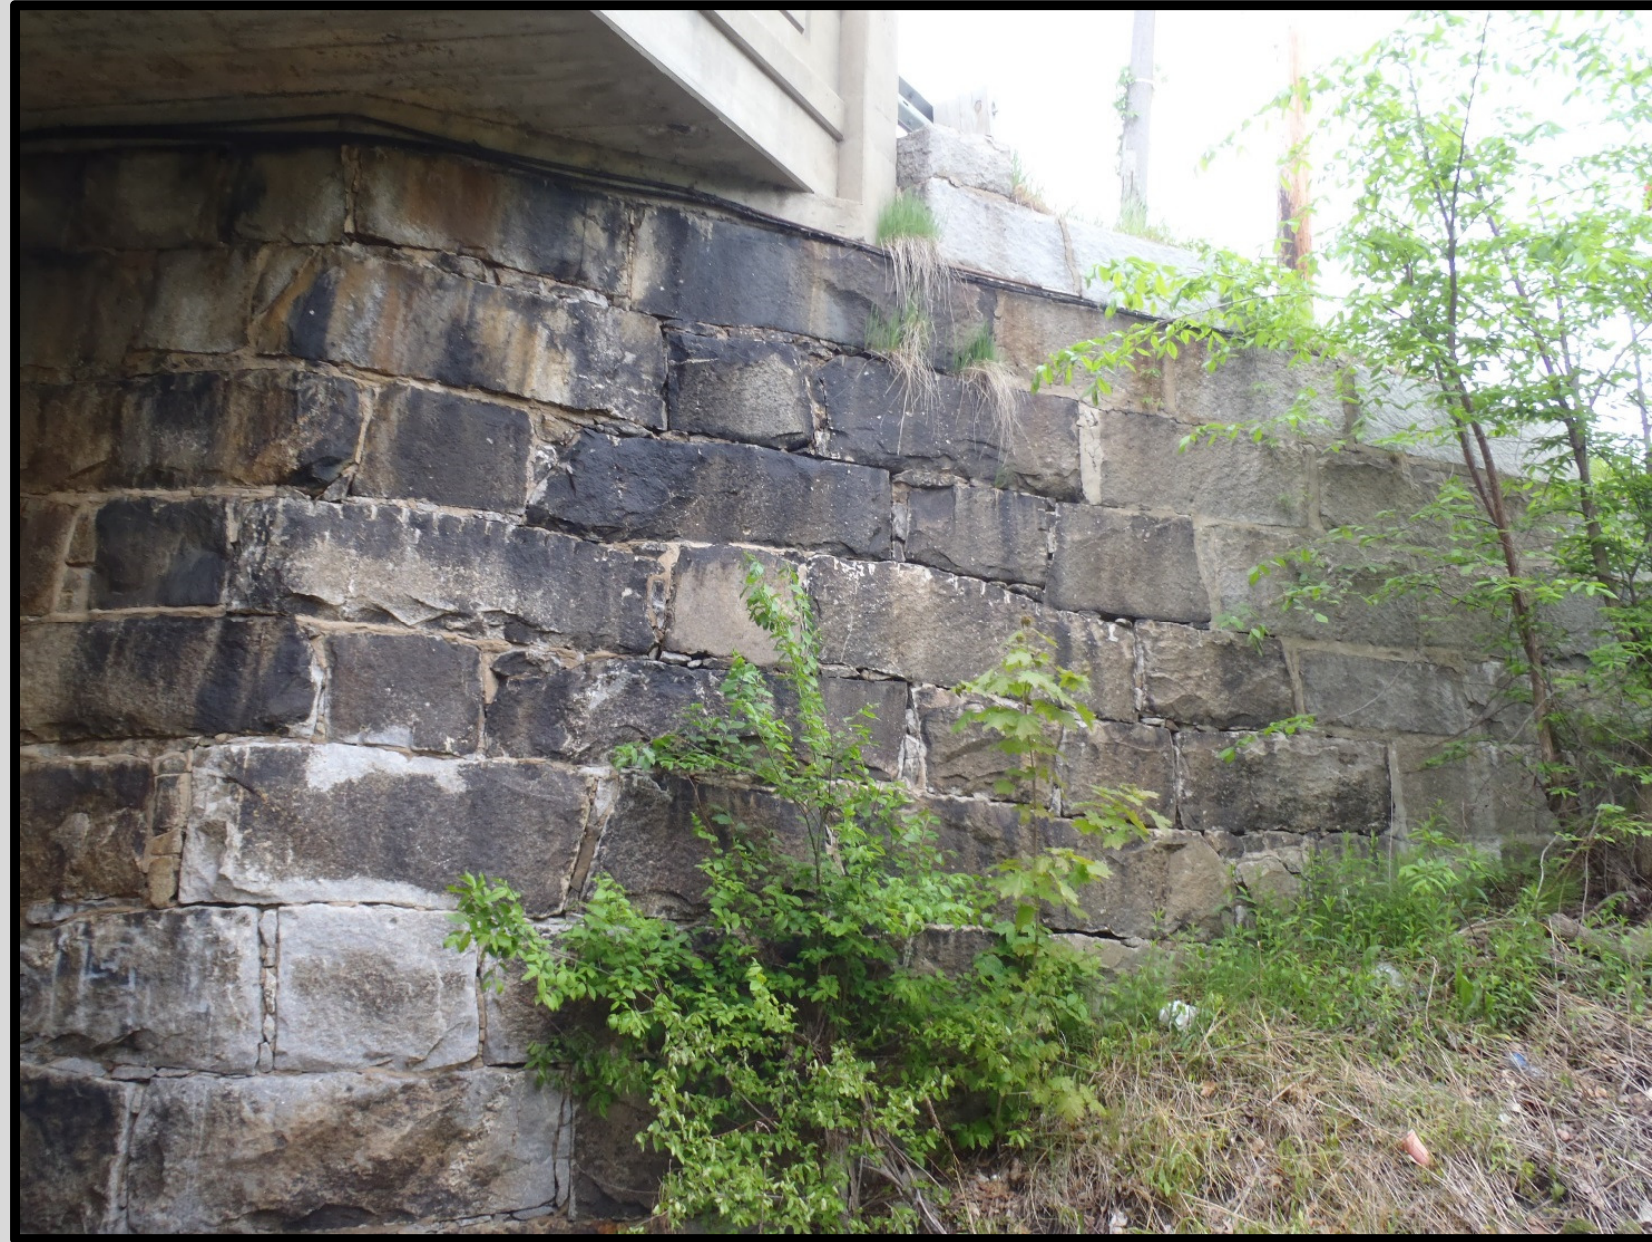
**East Abutment**

**Mortared Joints in Disrepair, Stone Stable With No Signs of Shifting**

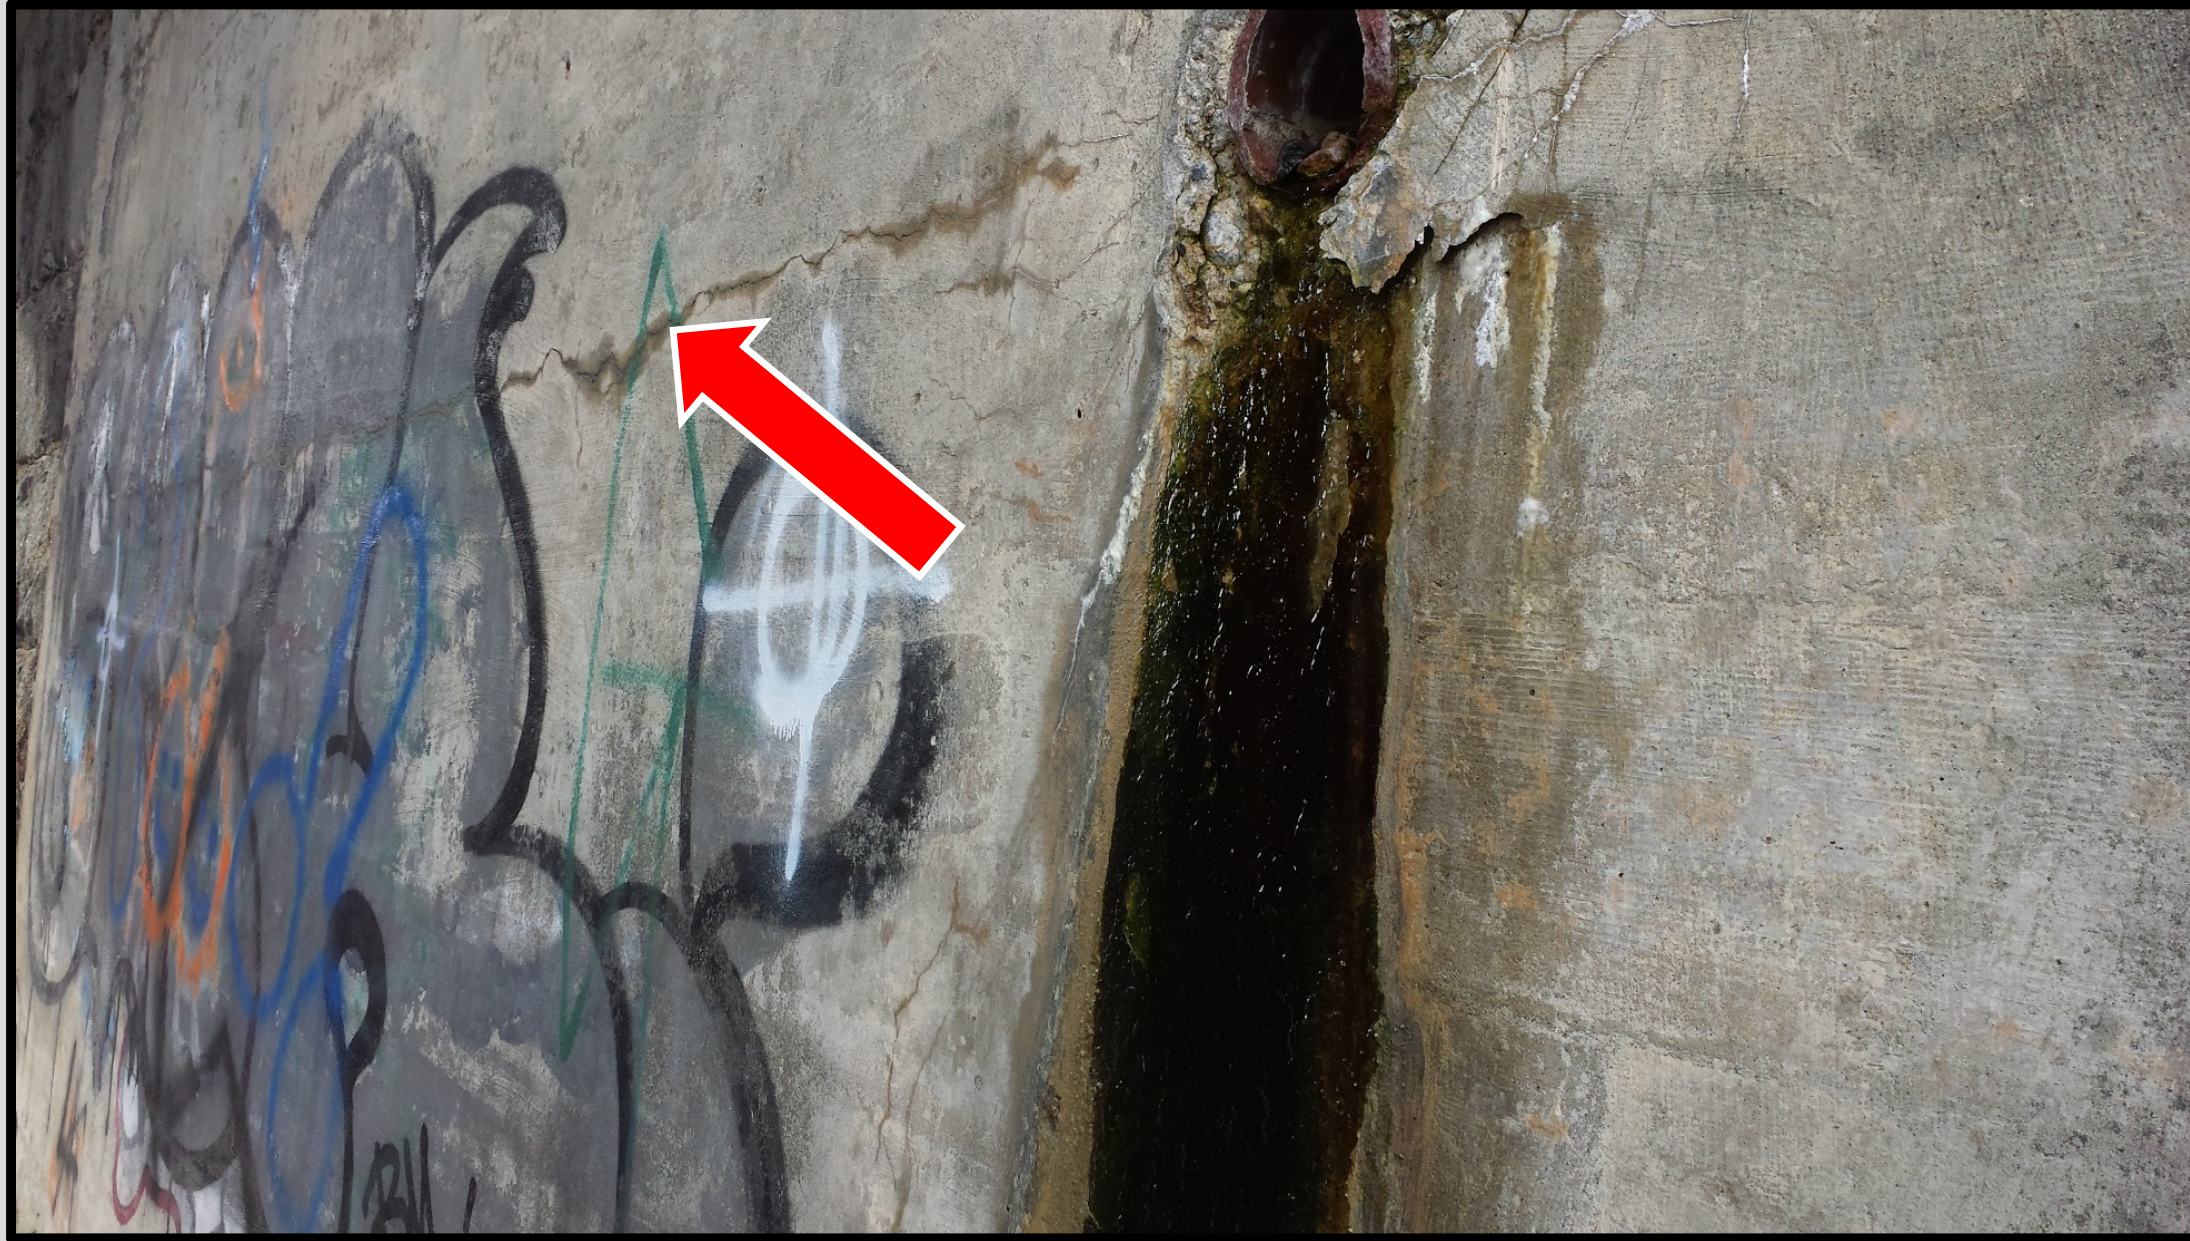
Retaining Wall – Cracking

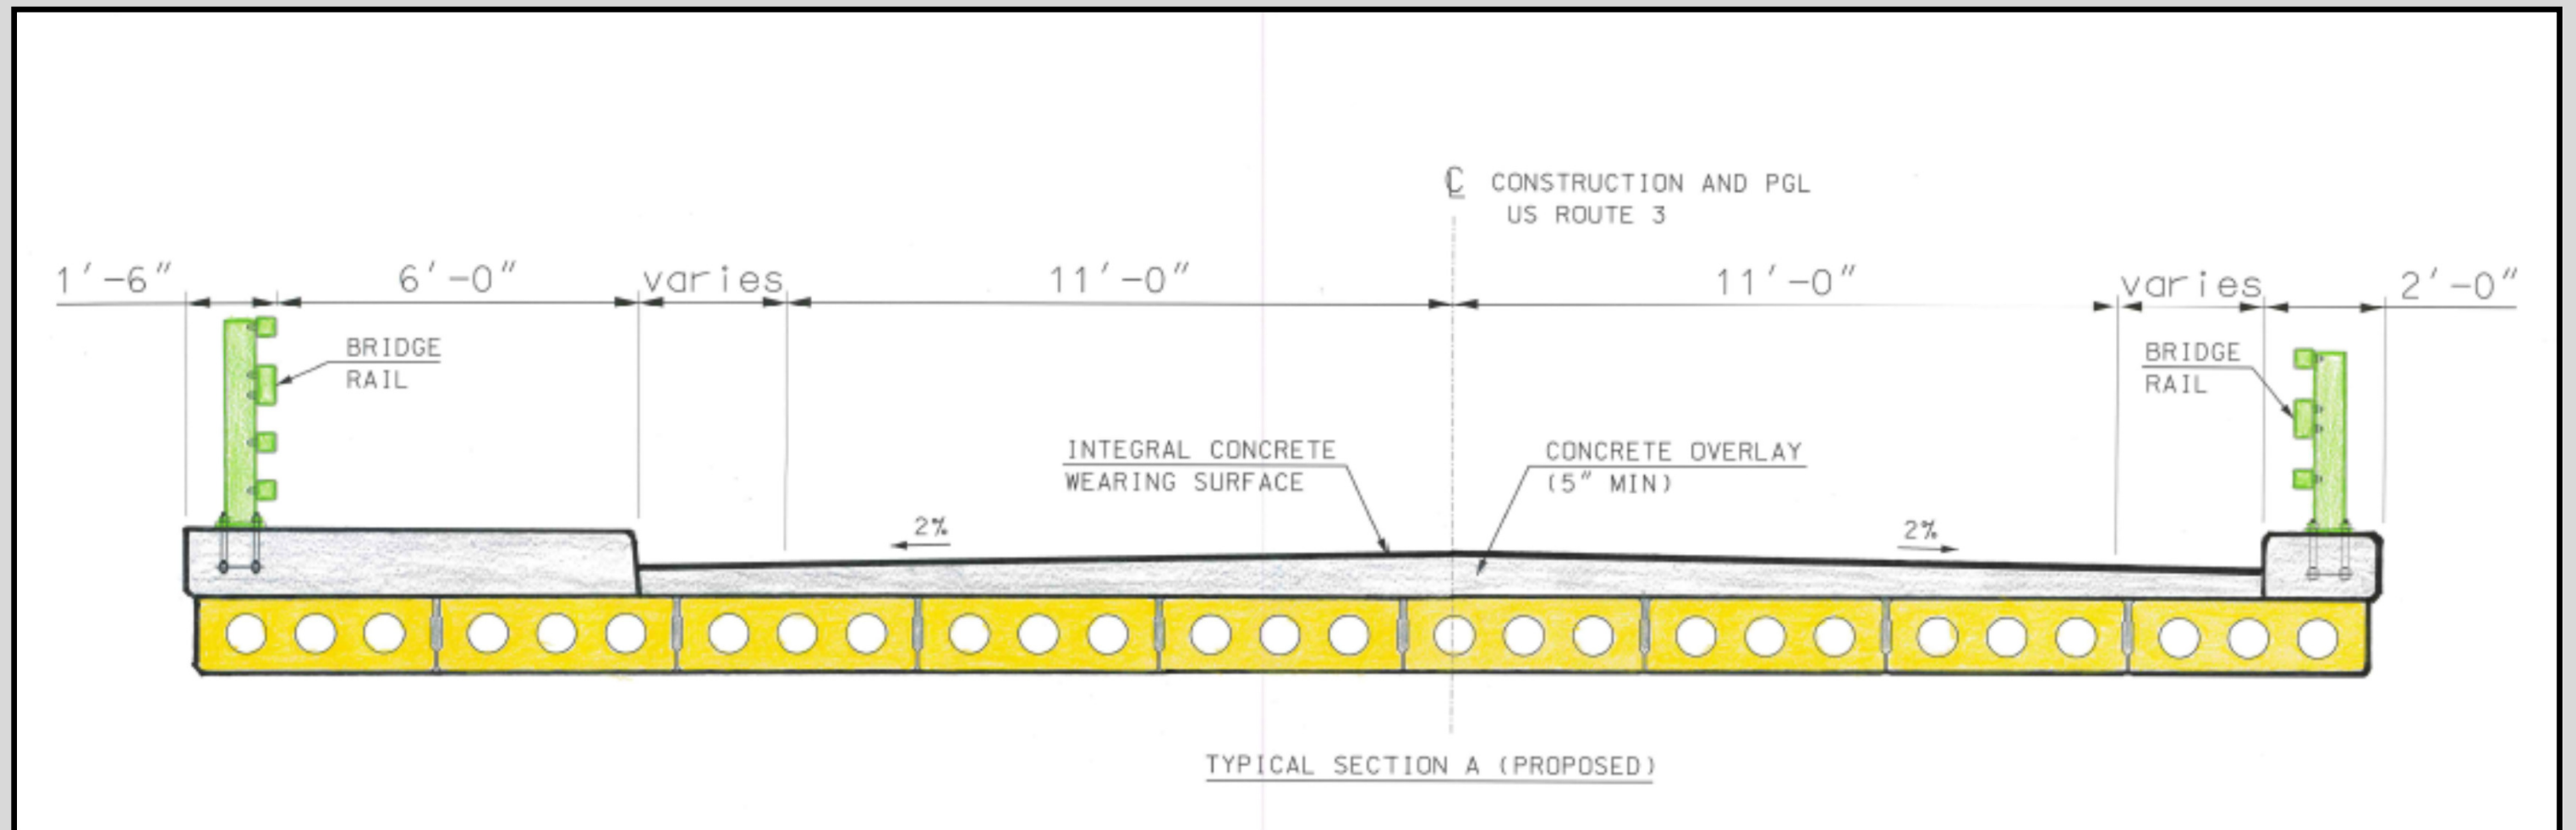
**Cast-In-Place (CIP) Very Similar**

- Steel beams with a concrete deck ⇒ Deep structure depth, clearance issues
- Cast-In-Place Concrete Slab ⇒ Slow to Construct
- **Precast-Prestressed Voided Slabs ⇒ Accelerate Schedule Advantages**

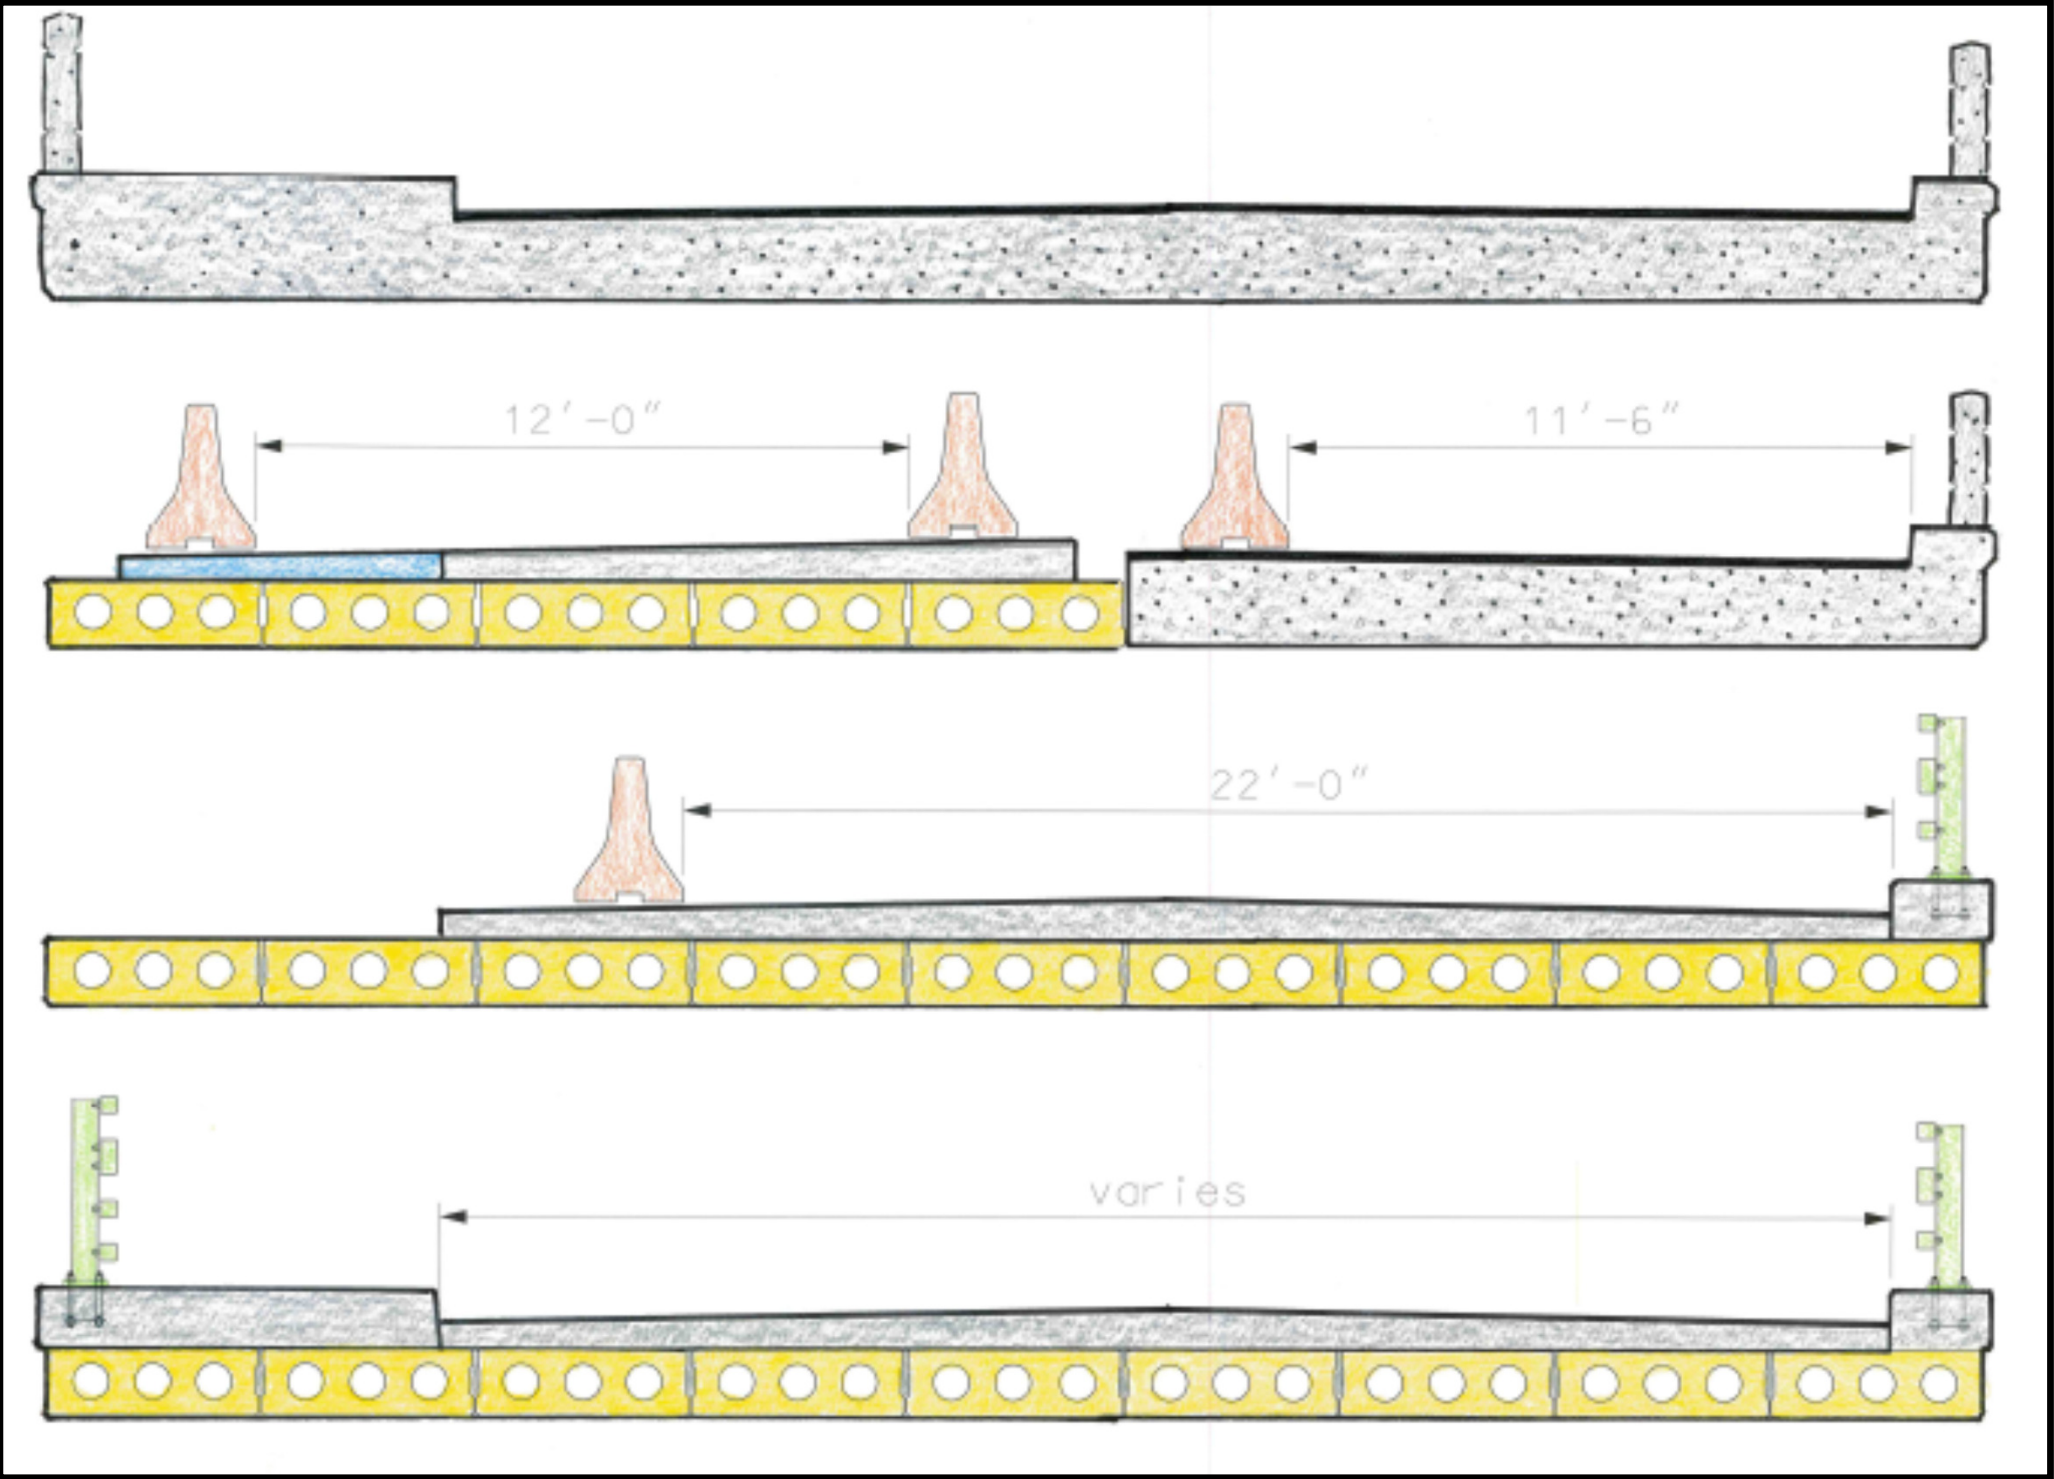
Existing

Phase 1

Phase 2

Phase 3

Final

- **Alternating One-Lane two-directional traffic via Signal Control**
- **Difficult due to narrow width of Structure and Close Proximity of Intersections**
- **Estimated 120 day Construction Time due to Site Constraints and Building a Bridge in Three Phases**
- **Cost approximately 25% More Than Bridge Closure Option**

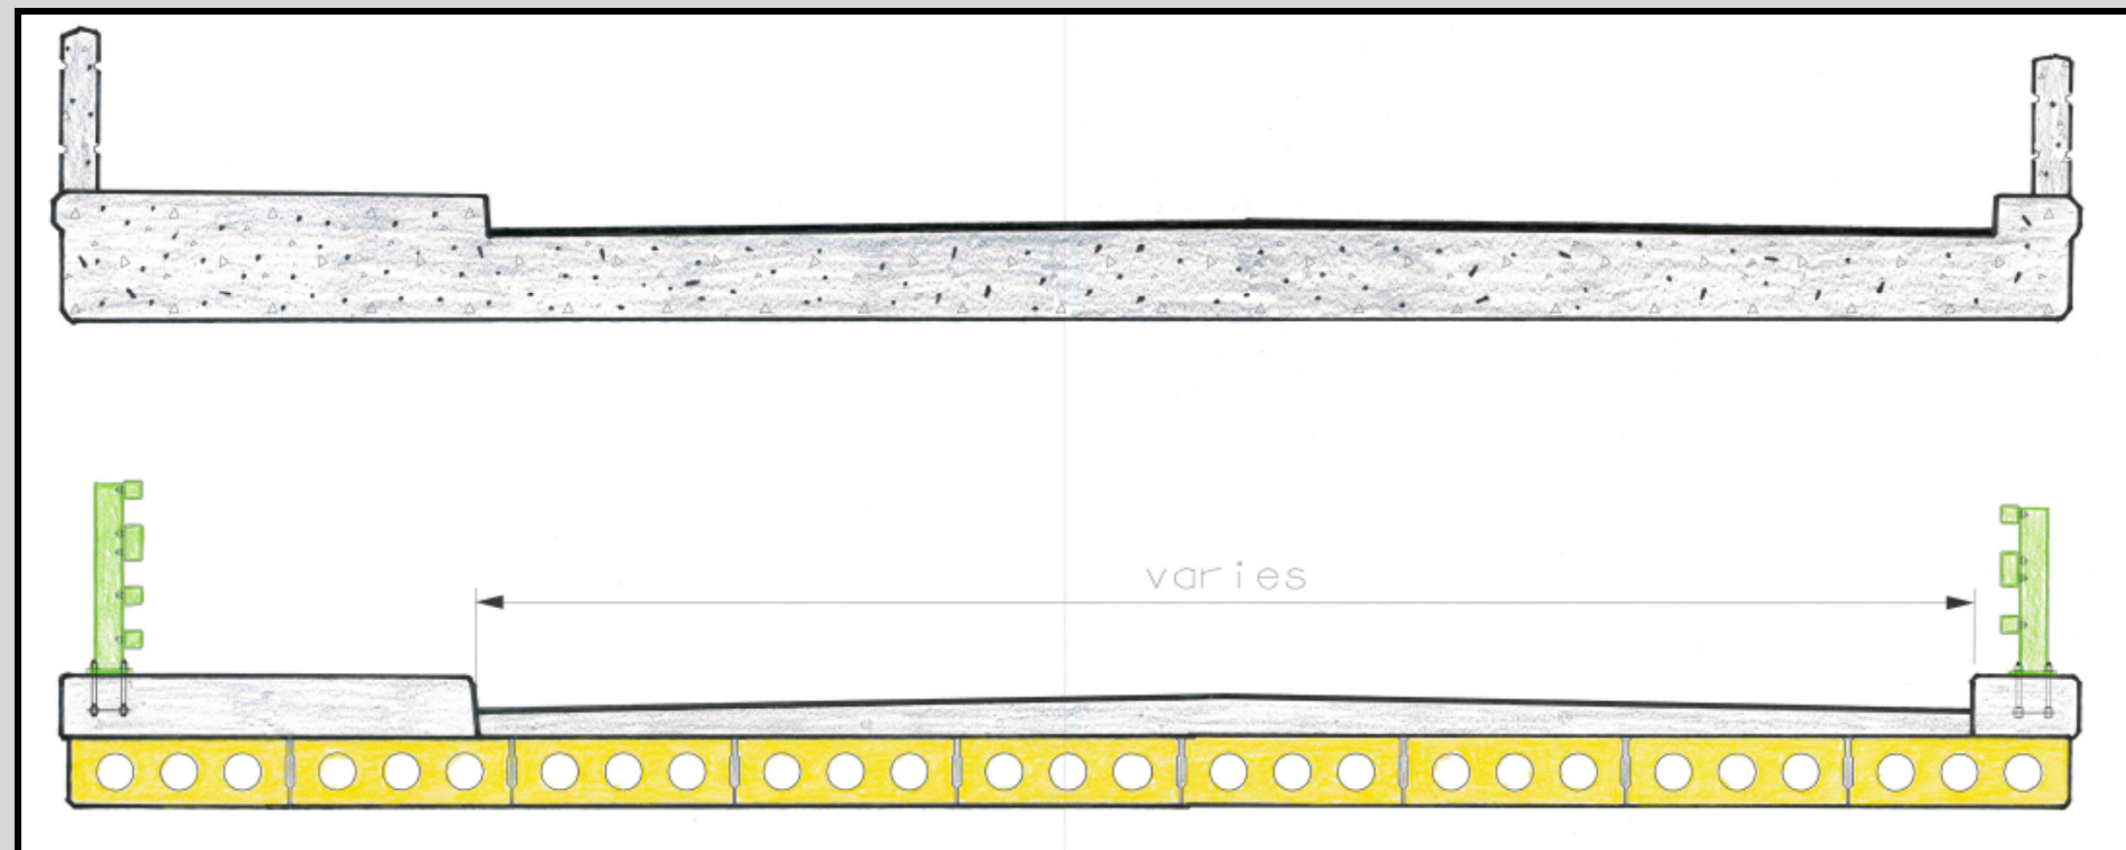
Existing

New / Proposed

- Accelerated Options
- Emergency Response Coordination Required
- 30 Day (Accelerated) Construction Lengths (April timeframe?)
- Most Economical
- Accelerated Option Recommended
